**BASIC TIME LINE FOR INVESTIGATION OF EVENT AT  
422 SOUTH 11<sup>TH</sup> STREET, OMAHA, NEBRASKA**

## Pipeline Failure Investigation Report

Pipeline System: Distribution Operator: Metropolitan Utilities District  
 Operator ID: 12390 Unit Number: 15-00-000 Activity Number: IR# 160031  
 Location: 422 South 11<sup>th</sup> Street, Omaha NE Date of Occurrence: 01/09/2016  
 Material Released: Natural Gas Quantity: 50,762 cft  
 State Arrival Time & Date: 1838 Ct 01/09/16 Total Damages \$: >\$5,007,627  
 Investigation Responsibility: X State \_\_\_ PHMSA \_\_\_ NTSB \_\_\_ Other (NRC) Report Number: 11376

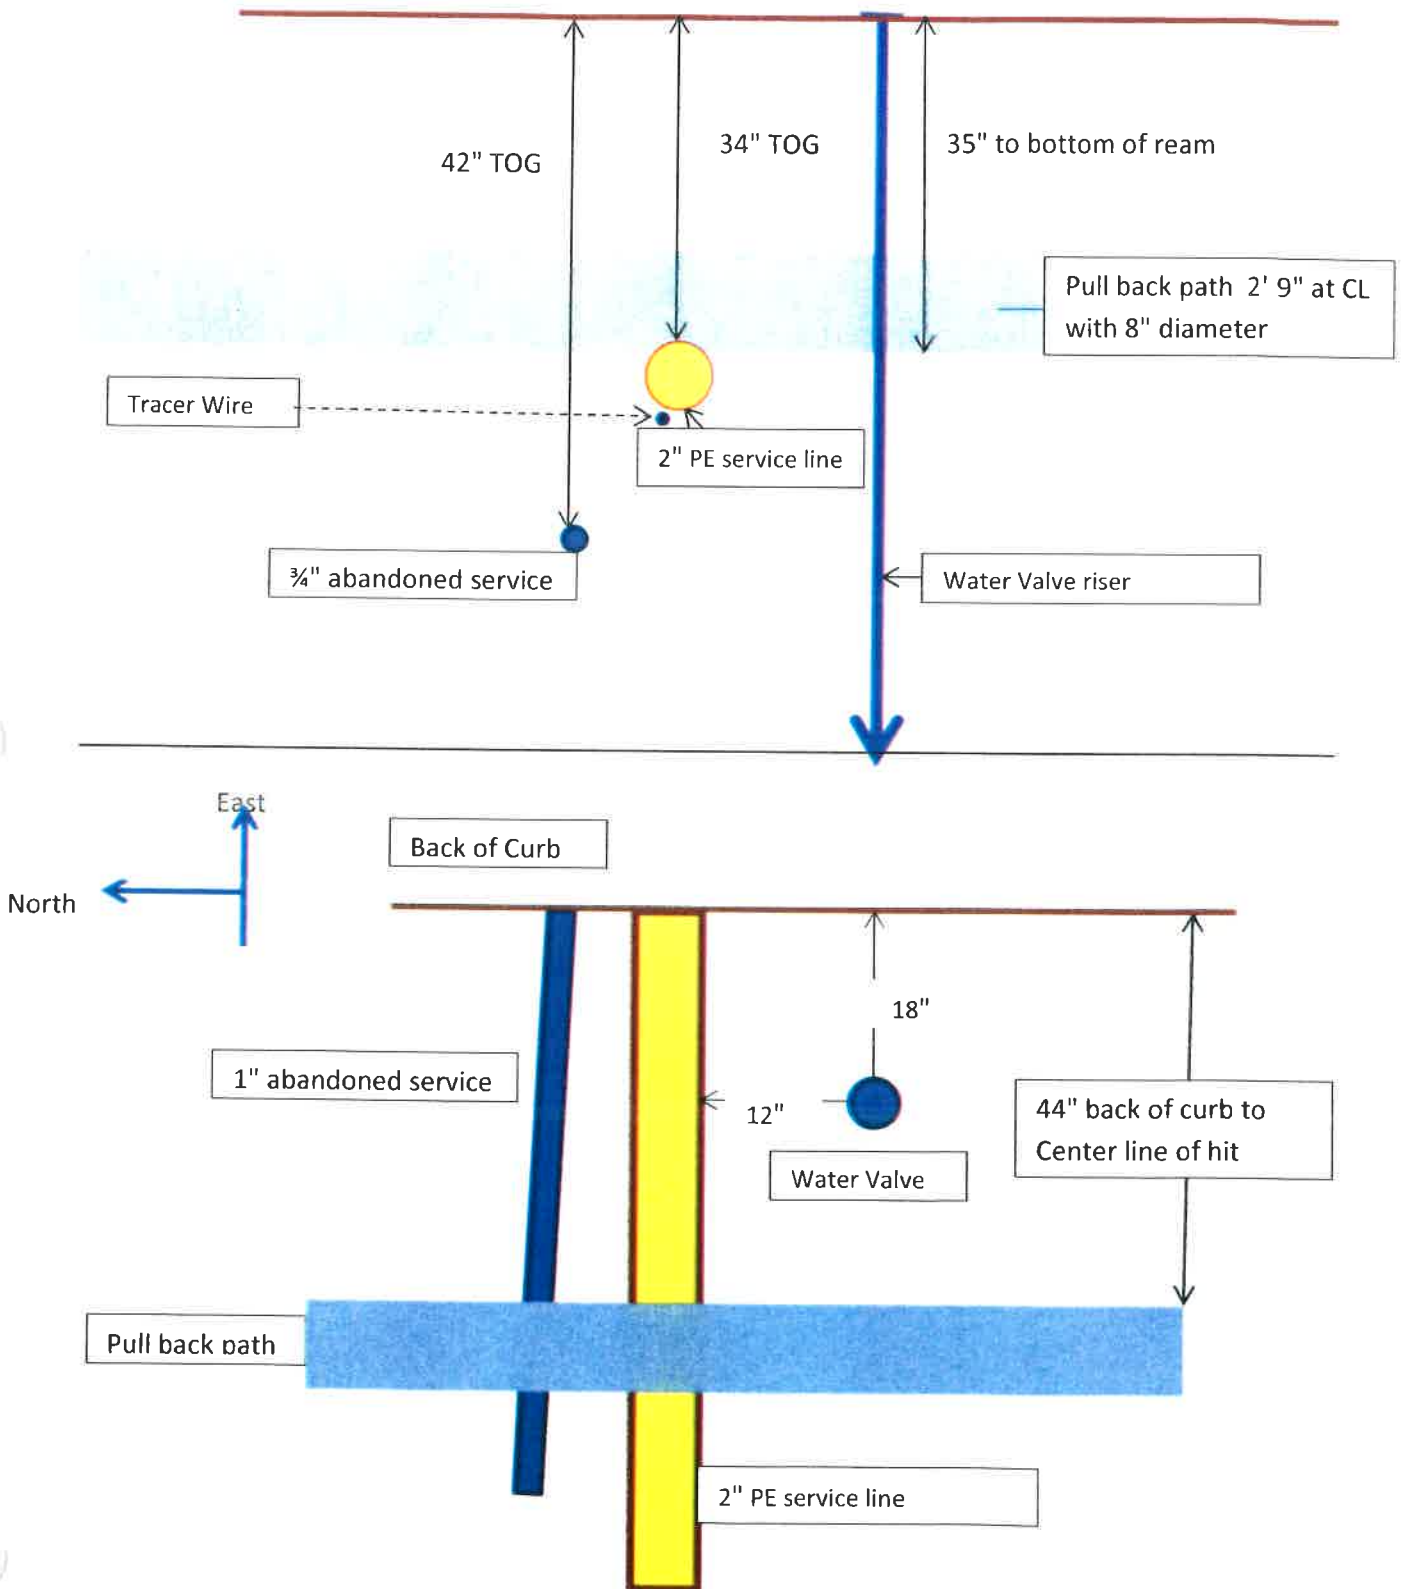
DIAGRAM of visual examination of damage area

Damages to pipeline consisted of a 1½" x 1" oval opening upon a 2" service, necessitated removal of 33" of 2" PE piping, and loss of a "bank" of eight (8) meters and corresponding service regulators associated service valves and fittings.

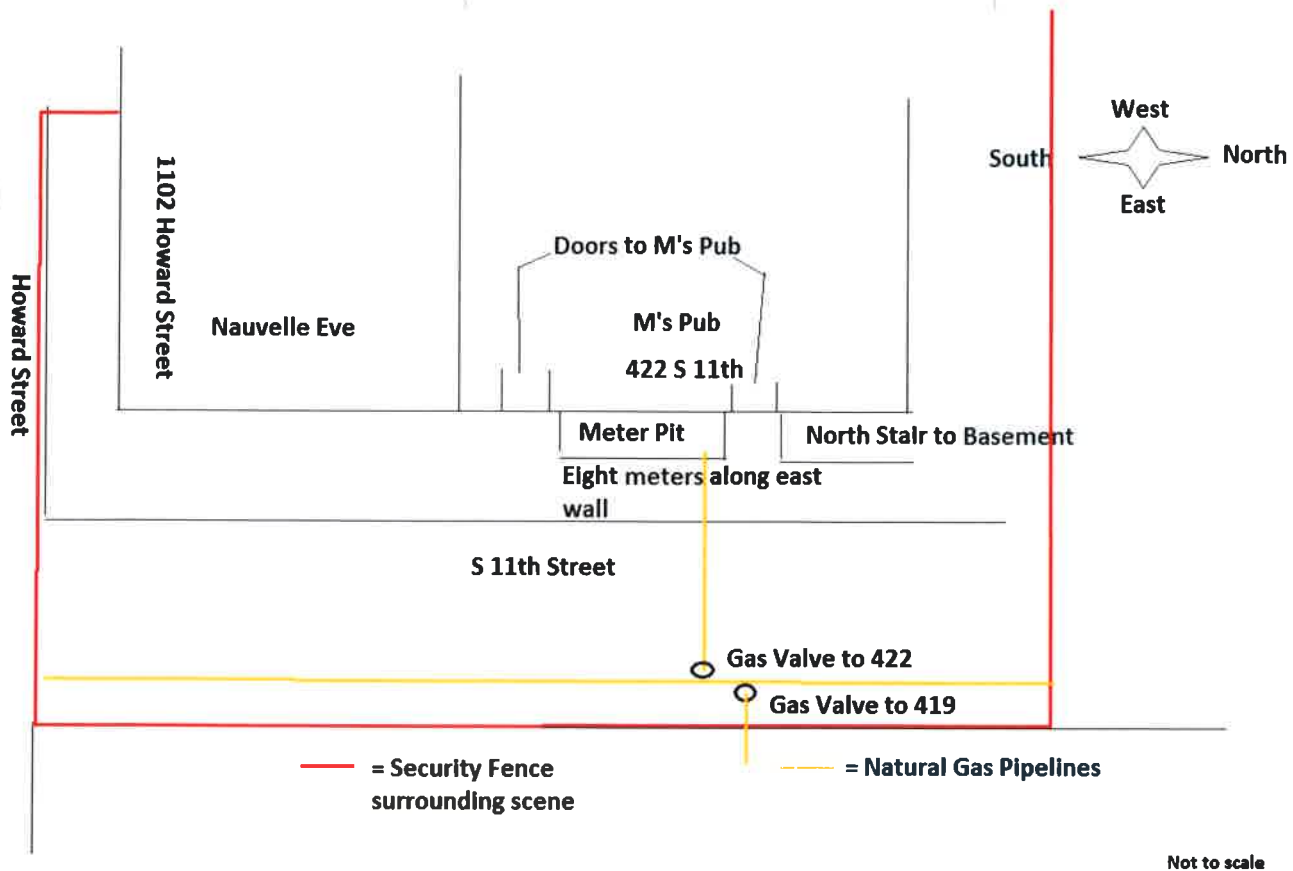
On April 13<sup>th</sup> the City of Omaha allowed access to the site of 422 S 11<sup>th</sup> Street, by afternoon the meter pit in front of 422 had the steel plate removed to allow access to inspect the natural gas meters that supplied natural gas to the building as well as adjacent building. This allowed investigators to inspect and photograph the meter sets involved in this incident. Photographs were taken throughout the day.

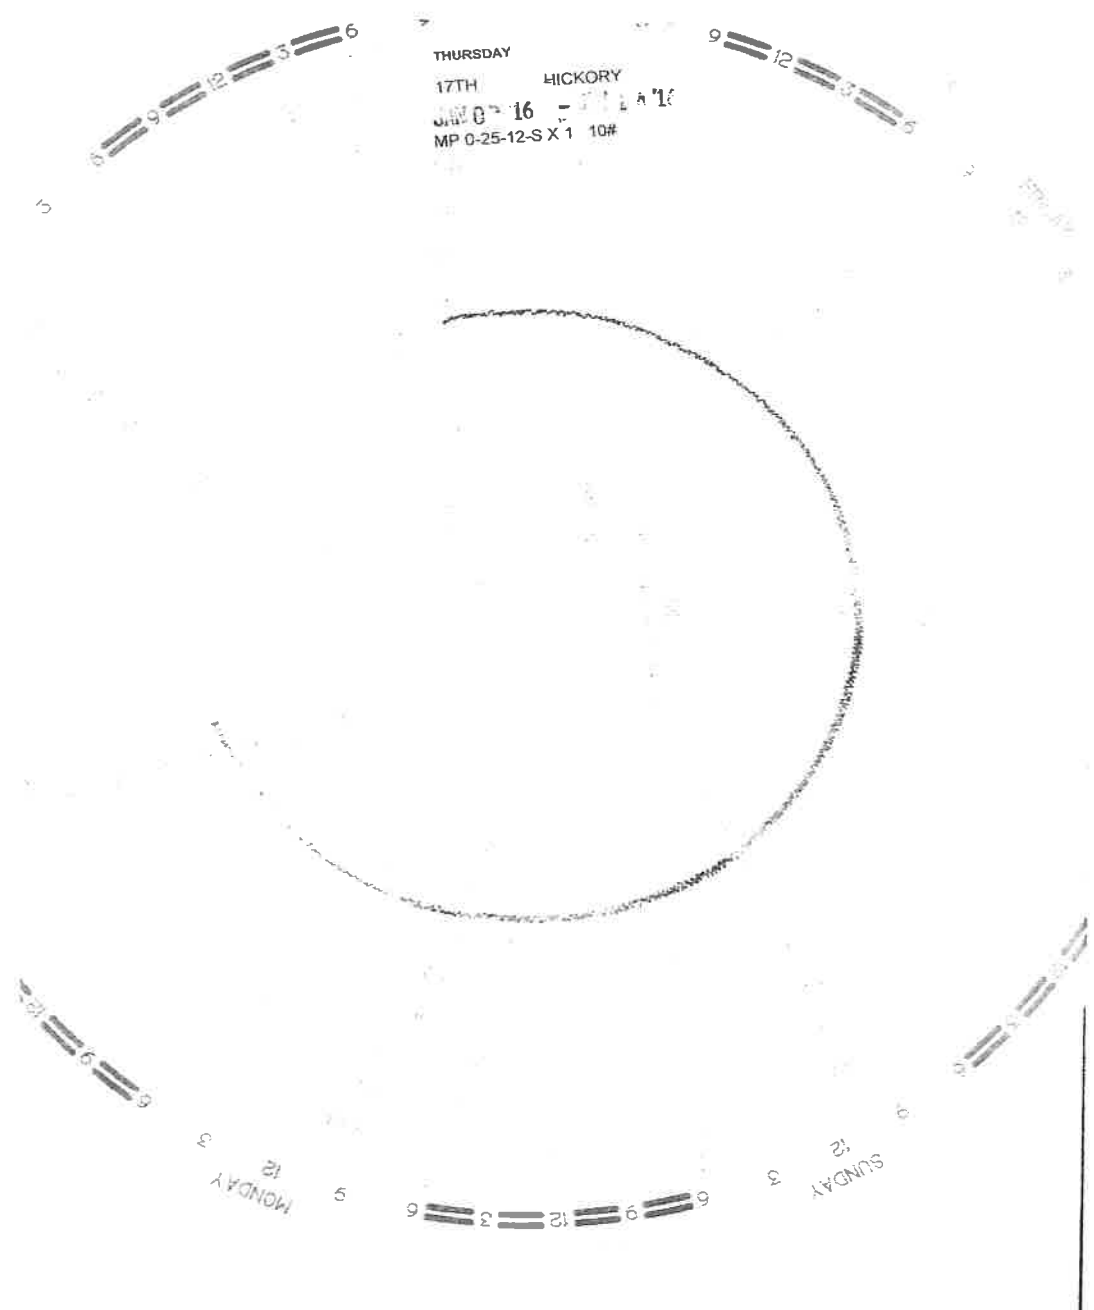
## Attachment 14: Pressure Chart from 17<sup>th</sup> & Hickory

Pressure at Time of Failure at Failure Site				
Pressure Readings at Various Locations:			Direction from Failure Site	
Location/M.P./Station #	Pressure (psig)	Elevation (ft msl)	Upstream	Downstream
<b>11<sup>th</sup> &amp; Hickory</b>	<b>9 psig</b>		<b>x</b>	
<b>19<sup>th</sup> &amp; Manson</b>	<b>9 psig</b>		<b>x</b>

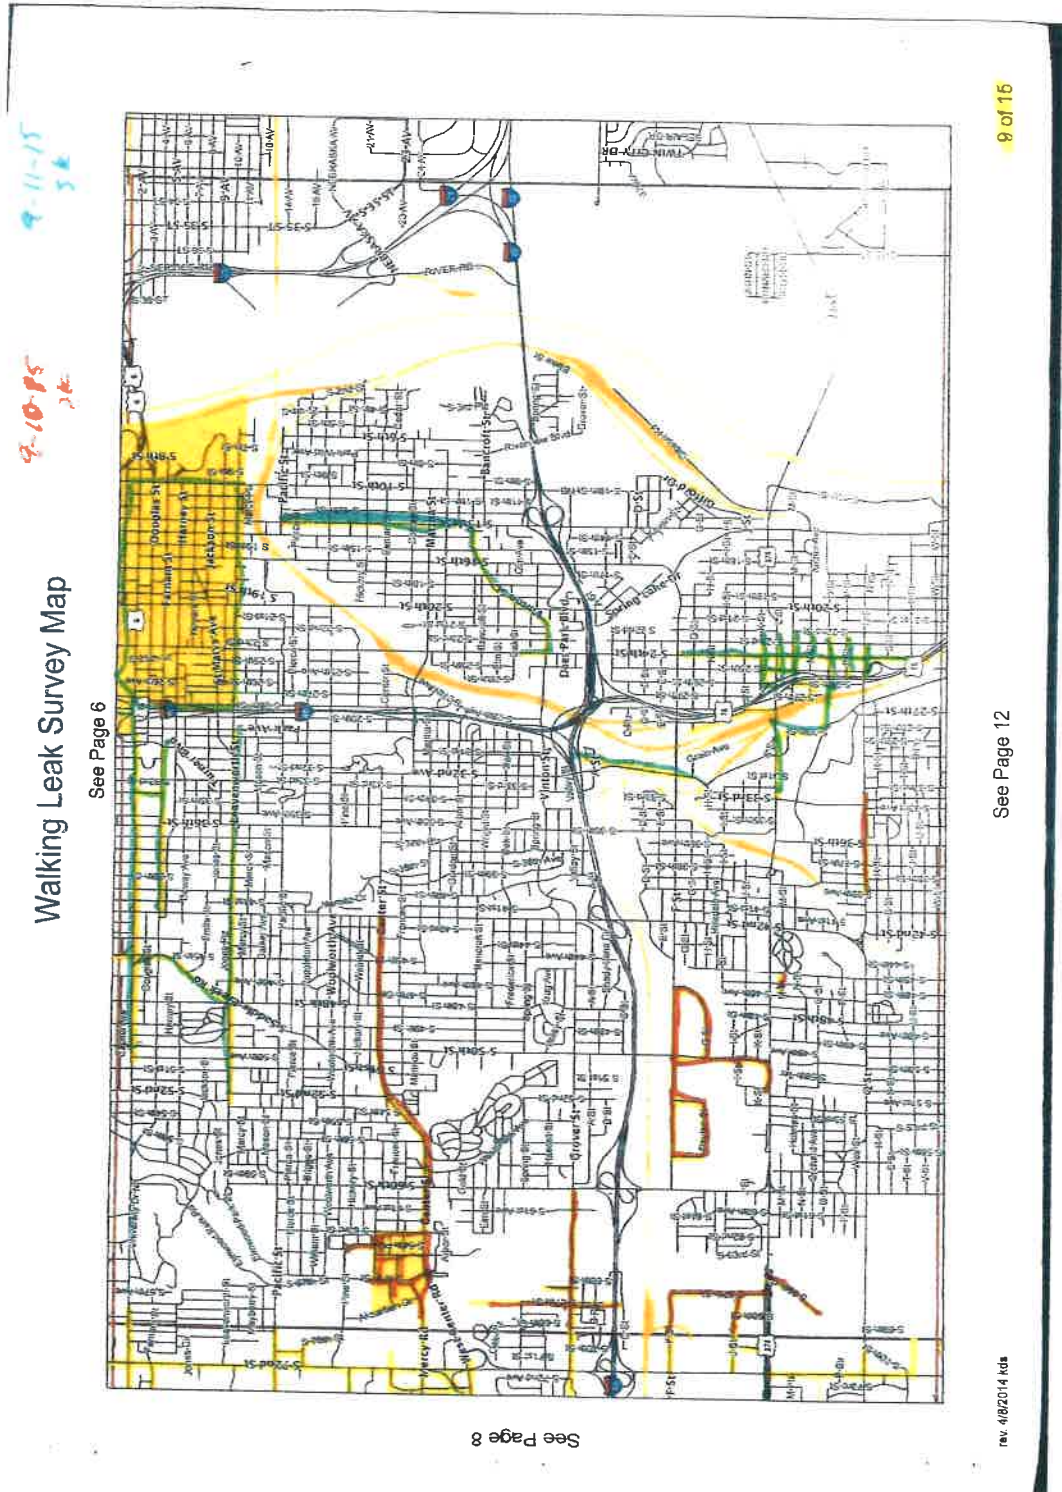
## Attachment 16: Leak Survey map for area 2015

Old Market area leak surveyed 9/10-11/2015 no reported underground leaks
