**BASIC TIME LINE FOR INVESTIGATION OF EVENT AT  
422 SOUTH 11<sup>TH</sup> STREET, OMAHA, NEBRASKA**

## Pipeline Failure Investigation Report

Pipeline System: Distribution Operator: Metropolitan Utilities District  
 Operator ID: 12390 Unit Number: 15-00-000 Activity Number: IR# 160031  
 Location: 422 South 11<sup>th</sup> Street, Omaha NE Date of Occurrence: 01/09/2016  
 Material Released: Natural Gas Quantity: 50,762 cft  
 State Arrival Time & Date: 1838 Ct 01/09/16 Total Damages \$: >\$5,007,627  
 Investigation Responsibility: X State \_\_\_ PHMSA \_\_\_ NTSB \_\_\_ Other (NRC) Report Number: 11376

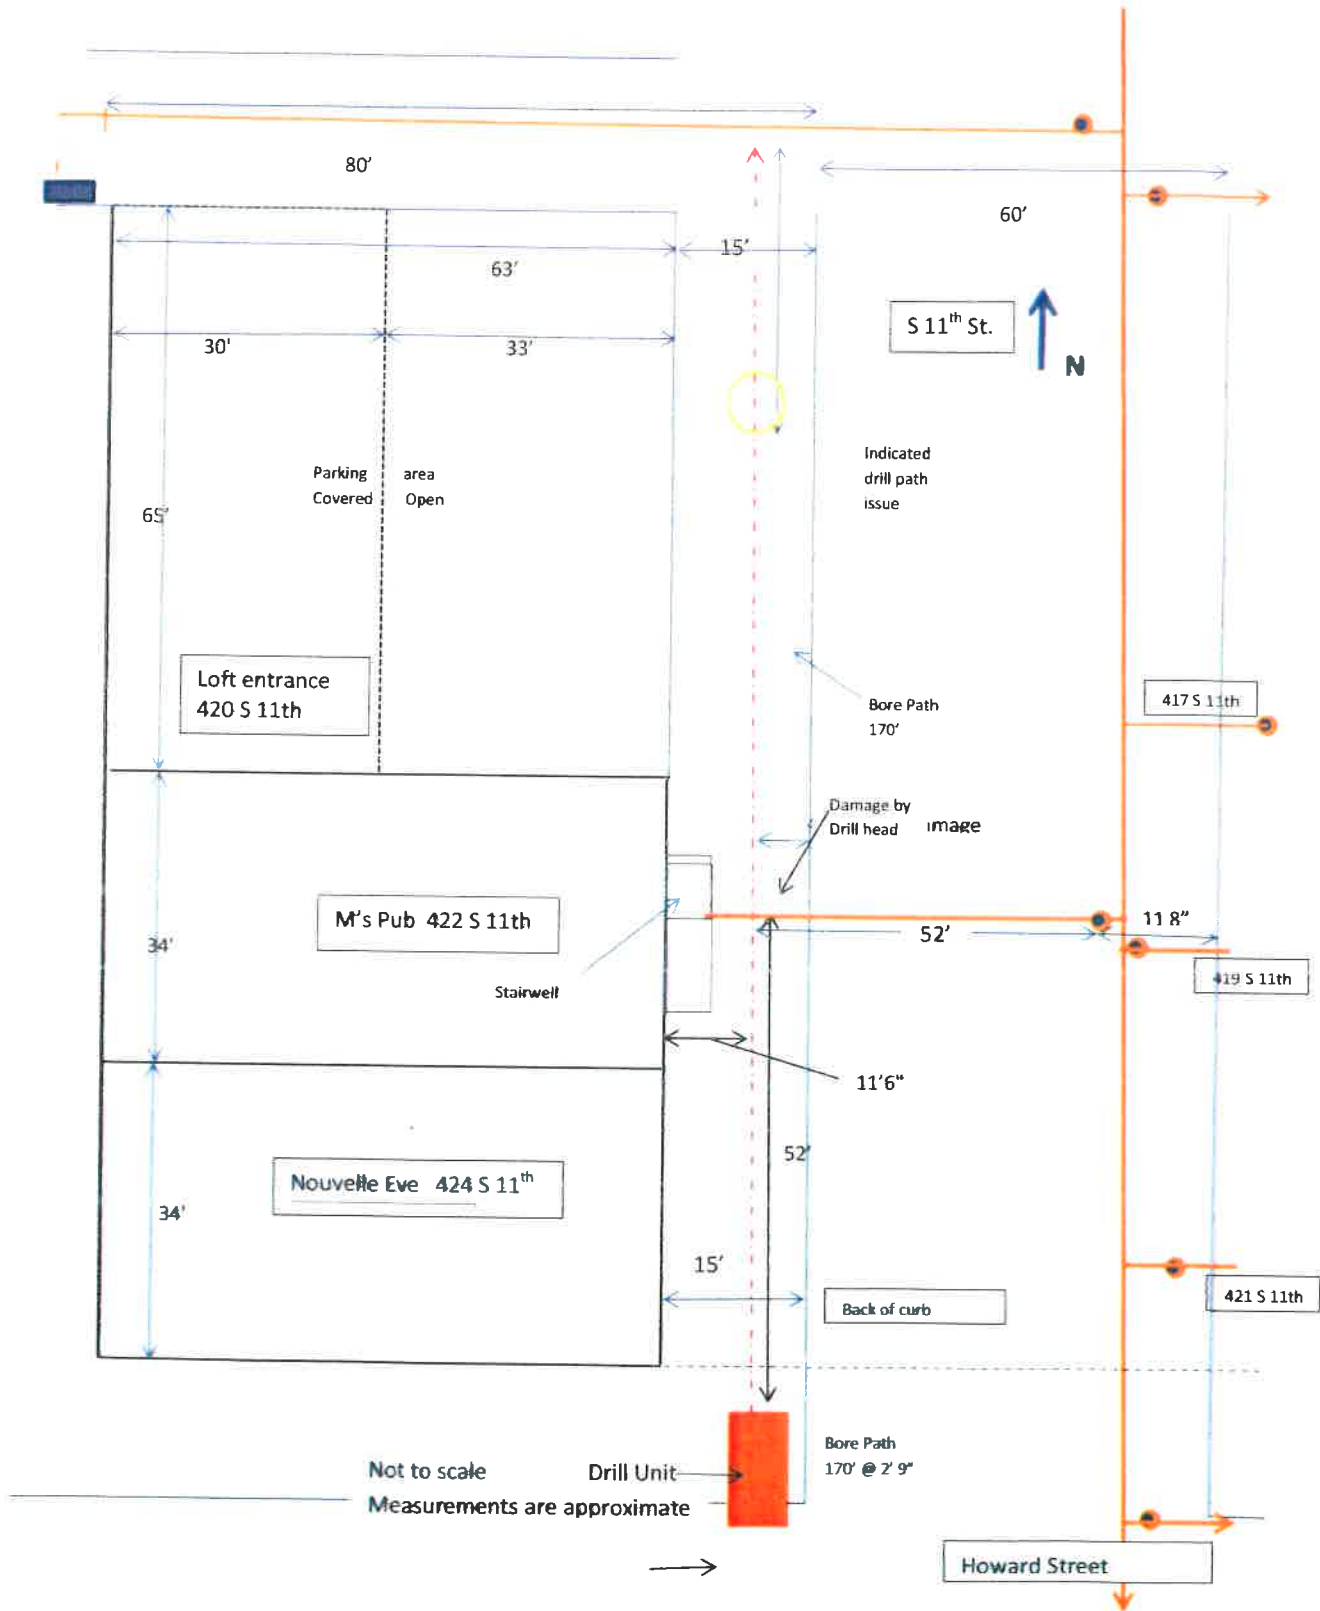
DIAGRAM of visual examination of damage area

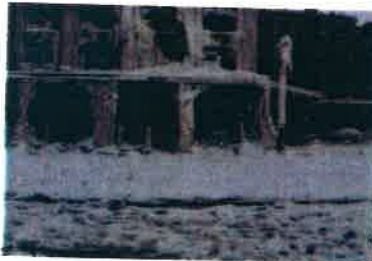
0911	Same, from above fence.	0961	At east curb looking west , East side of S 11 <sup>th</sup> Street looking at service curb box(s) 419 to lower, 422/424 upper.
0912	Pull back full frontal picture 422 S 11 <sup>th</sup> .	0962	Street level, looking west from East side of S 11 <sup>th</sup> Street looking south, service curb box(s) 419 to lower, 422/424 upper.
0913	Fence being removed.	0963	West side of S 11 <sup>th</sup> Street, south of 422 S 11 <sup>th</sup> , red paint markings in street.
0914	Supports for fence removed, clear plastic show condition of street.	0964	10' west of east curb, East side of S 11 <sup>th</sup> Street looking south , faint yellow mark , center of picture
0915	From stoop at "All about Me" directly east of 422 S 11 <sup>th</sup> St. looking southwest (Investigator Dooley).	0965	10' west of east curb, East side of S 11 <sup>th</sup> Street looking south, service curb box(es) 419 to left, 422/424 to right.

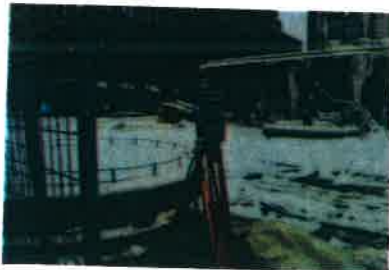
0918	From northeast corner of Howard & S 11 <sup>th</sup> looking northwest, condition of street, ground heater and prep for removing tarps.	0968	Faint yellow mark for gas main east side of S 11 <sup>th</sup> Street.
0919	Receiver for GIS locating equipment (Longitude/Latitude).	0969	Faint yellow mark for gas main east side of S 11 <sup>th</sup> Street.
0920	Transceiver for GIS locating equipment) Leica.	0970	Faint yellow mark for gas main east side of S 11 <sup>th</sup> Street.
0921	Carrying cases.	0971	Faint yellow mark for gas main east side of S 11 <sup>th</sup> Street.
0922	Setting up transceiver for GIS locating equipment.	0972	15' east of west curb looking into 422 S 11 <sup>th</sup> Street.
0923	1 <sup>st</sup> location ID point (Service valve box 419 S 11 <sup>th</sup> ).	0973	15' east of west curb looking at curb line 422 S 11 <sup>th</sup> Street.
0924	Yellow paint on bricks for service line for 419 S 11th Street.	0974	15' east of west curb looking at curb line 422 S 11th Street angled to left, blue marking for water to right of pic (no yellow markings).

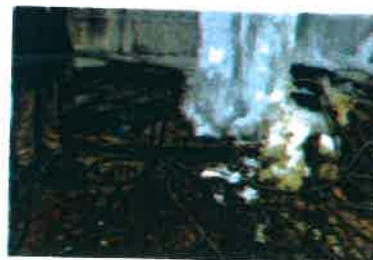
0933	Error.	0983	Close up from parking area of north build line for M's Pub looking south towards Howard. Blue marking lower center of picture.
0934	From center line of S 11th street east of 422 S 11th Street, looking west at curb line and side walk in front of M's Pub. Notice color of blue marking.	0984	Additional blue mark, west side of S 11th east of M's Pub.
0935	15' east of west curb at 422 S 11th Street, looking west at curb line and side walk in front of M's Pub. Notice color of blue marking approx. 3' to right is abandoned service valve box for previous service line. Service replace in 08/2009.	0985	Additional blue mark, west side of S 11 <sup>th</sup> east of M's Pub.
0936	Close up of abandoned service valve box for previous service line.	0986	Close up of additional blue mark, west side of S 11th east of M's Pub 422 S 11 <sup>th</sup> .
0937	15' east of west curb at 422 S 11th Street, looking east at center of street, surveying for yellow markings.	0987	Close up of curb line in front of M's Pub, (422 S 11th) water line to the left, abandoned gas service valve box to right.

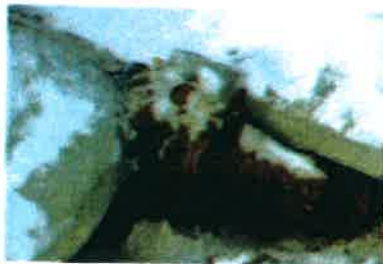
1018	Closer look at drill unit with of reamer on end of drill stem "8" diameter"	1047	Look down into excavation zone. Measure device resting on top of abandoned gas service (black pipe). Yellow pipe is existing 2" PE gas service line. (damage visually apparent on yellow pipe at center of picture. To bottom center of picture is water service valve riser.
1019	Close up of reamer with turn buckle	1048	Close look down into excavation zone. Measure device resting on top of abandoned gas service (black pipe). Yellow pipe is existing 2" PE gas service line. (damage visually apparent on yellow pipe at center of picture. Bottom of picture is water service valve riser.
1020	Look west from in front (north side) of drill unit	1049	Close up, look down from northwest side of excavation at damaged pipe segment
1021	Ditch Witch drill Unit #DB28	1050	Close up, look down from northwest side of excavation at damaged pipe segment, (coloring on yellow pipe?)

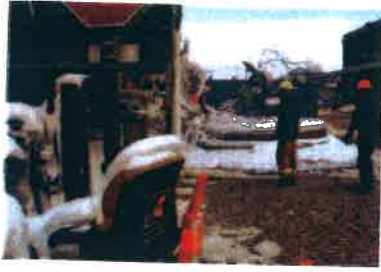
1022	From northwest corner of S 11 <sup>th</sup> & Howard St. looking north. (bore path approximately 3' west of west curb line of S 11 <sup>th</sup> St.)	1051	Repositioned, close up, look down from northwest side of excavation at damaged pipe segment.
1023	Look west from west curb at door way to (left) Nouvelle Eve (right) M's Pub "422 S 11 <sup>th</sup> St.. Stairwell behind grates	1052	On east side of excavation, looking down , to right is opening from bore path
1024	Look west from west curb at door way to door way of M's Pub (422 S 11 <sup>th</sup> ) at bottom of picture yellow flag above 2" PE service, blue for water service (extreme right bottom corner "service valve for abandoned service ie 2009"	1053	Reposition to west side of excavation, top of picture is tape measure. Water service valve cover to upper right. (indicating that yellow pipe is approximately 13" from center of water valve to center of yellow pipe

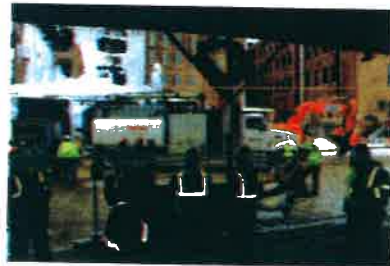
1032	Look west from center of block (400) from sidewalk on east side of S 11 <sup>th</sup> , top step of "All About Me Boutique" ... Vacuum truck being positioned	1061	Reposition to southwest corner of excavation zone. Look east. End of tape positioned against back of curb (west side of S 11 <sup>th</sup> Street) Damage to top of yellow pipe, at 44" west of back of curb.
1033	Look west from center of block (400) from sidewalk on east side of S 11 <sup>th</sup> zoom to see positioning of vacuum stem for excavation.	1062	Slip ( look down over railing in front of M's Pub into stairwell (full of water now frozen)
1034	Look north northwest from center of block (400) from sidewalk on east side of S 11 <sup>th</sup> at curb line on east side of S 11 <sup>th</sup> (Vacuum truck in position )	1063	Look west from trench box, down over railing in front of M's Pub into stairwell (full of water now frozen)
